2009 TL: New Model Body Repair Information

DISCLAIMER: This publication contains a summary of new body and vehicle technology that may affect collision and other body repairs. Always refer to the appropriate service and body repair manuals for complete repair information. A subscription may be purchased at: techinfo.acura.com

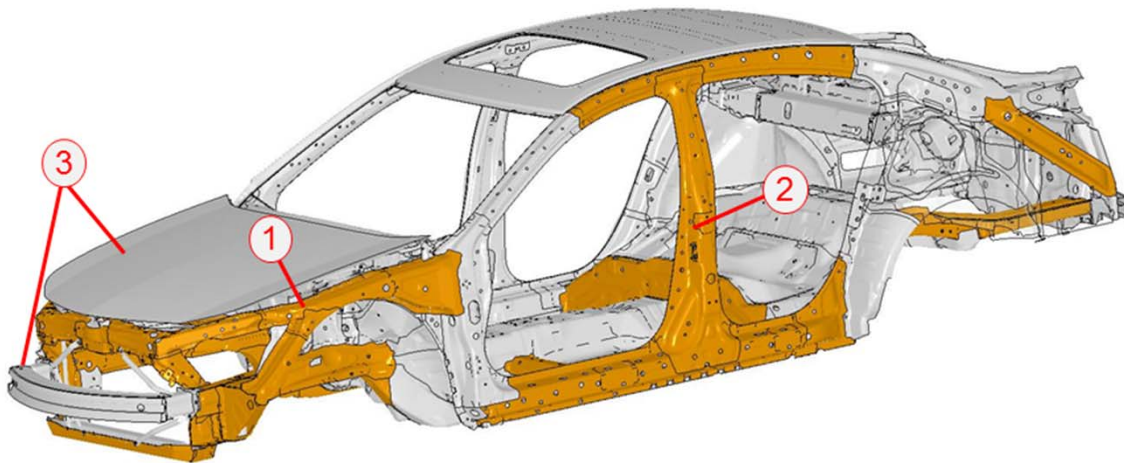
1. Advanced Compatibility Engineering™ (ACE™) body structure.
2. Body construction using 48%+ high tensile strength steel, including 5%+ in grades 980, and 1,500 MPa.
3. Aluminum body components used in key areas for weight reduction and improved fuel efficiency.

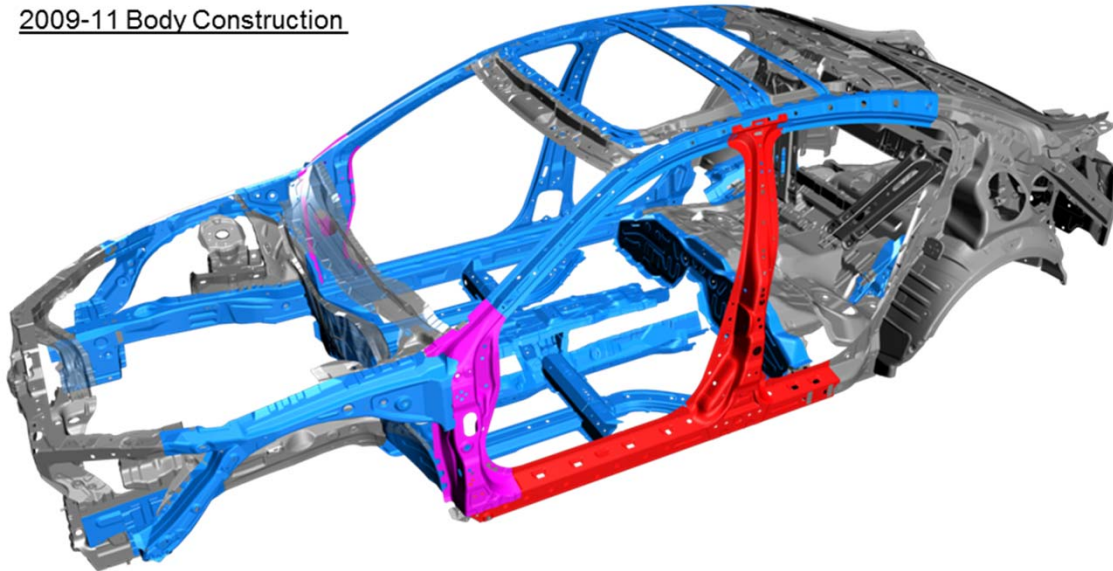
2009-11 Body Construction

- Steel parts are color-coded based on their tensile strength in megapascals (MPa).
- High strength steel is defined as any steel with a tensile strength of 340 MPa or higher.
- Steel repair and welding procedures vary depending on the tensile strength of the parts involved.

270 MPa
440 MPa
590 MPa
980 MPa
1,500 MPa

These illustrations are for general reference only. Some body parts are constructed from multiple layers of different tensile strength steels. Always refer to the body repair manual body construction section for specific steel tensile strength information.

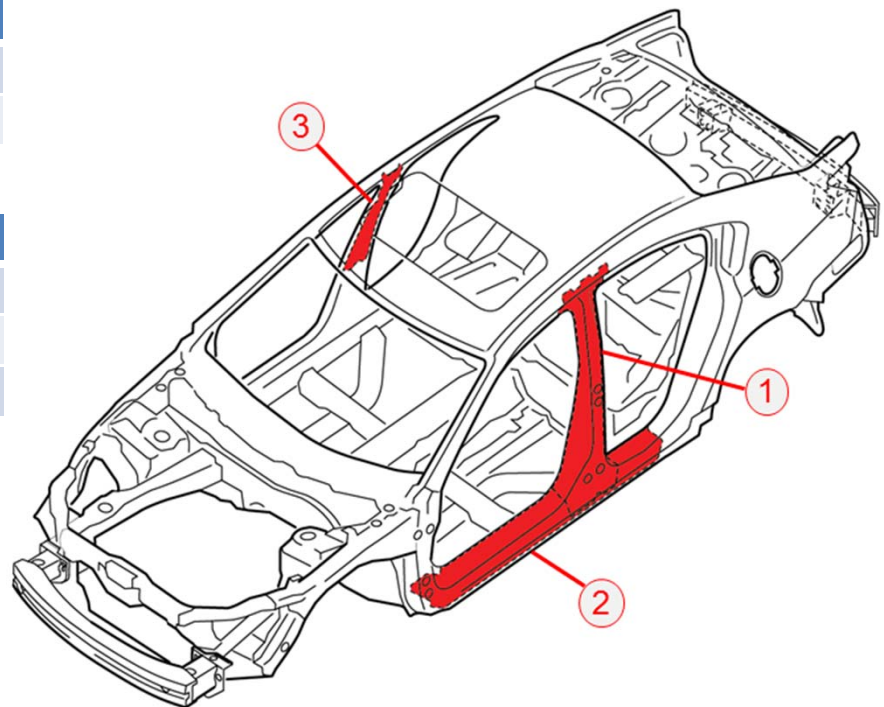
The numbered parts in the diagrams below are constructed of 1,500 MPa steel:

2009 – 2011 Models

| 1 | Center Pillar Stiffener |
| 2 | Side Sill Reinforcement |

2012 – 2014 Models

| 3 | Center Pillar Inner Stiffener |

1,500 MPa steel is stronger than ordinary steel, so it can help protect vehicle occupants while reducing overall vehicle weight to improve fuel efficiency.

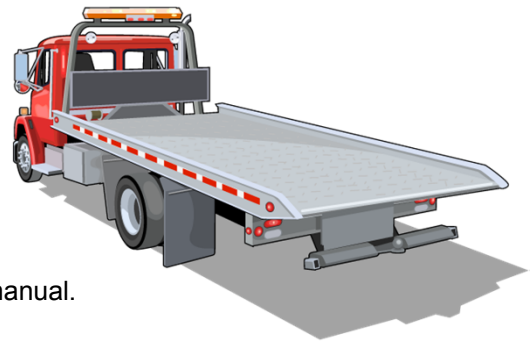
- Lift or jack only at the specified points to avoid damaging the vehicle.
 - Do not lift or tow this vehicle by its bumpers, or serious damage will result.
- For more information, refer to “Lift and Support Points” in the appropriate service or body repair manual.

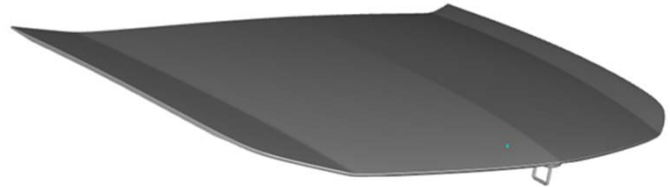
The hood panel and both bumper beams are constructed of aluminum alloy.

Hood Panel

Front Bumper Beam

Rear Bumper Beam

- Do not repair the bumper beams if damaged.
- The aluminum hood may be repaired by body shops that have a dedicated aluminum repair facility and separate tools.
- To prevent galvanic corrosion, some fasteners for aluminum parts are considered one-time use and must be replaced if removed. Refer to the service or body repair manual for more information.

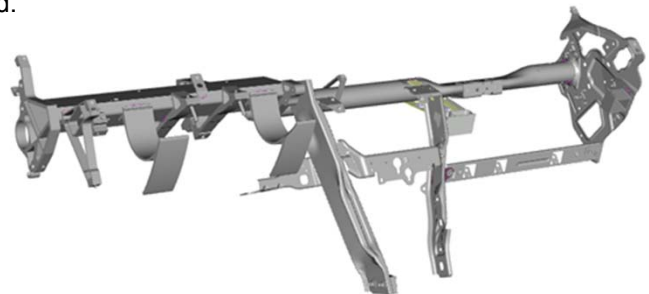
Aluminum Steering Hanger Beam

The steering hanger beam provides mounting for the steering column and dashboard components.

- The beam uses aluminum construction for weight savings.
- Do not repair the steering hanger beam if it is damaged.
- Special threaded collar bolts are used on the passenger side of the beam to compensate for any variation in body dimensions.
- A specific installation and bolt tightening procedure is required.
- Refer to “Dashboard/Steering Hanger Beam Removal and Installation” in the service manual for complete information.

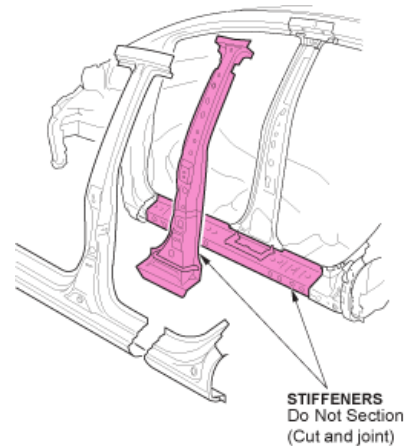
- Avoid sectioning (cut and joint) except for outer panels and floor panels unless a specific procedure is provided in the body repair manual.
- Replace body structural components as assemblies that match the replacement parts configuration.
- Refer to “Front Side Frame and Rear Frame Cutting and Splicing” in the body repair manual for sectioning opportunities.

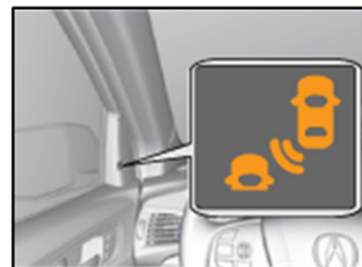
BSI Alert Indicator

Models equipped with this system can be identified by this BSI Alert Indicator, located on both front doors near the outside rearview mirror.

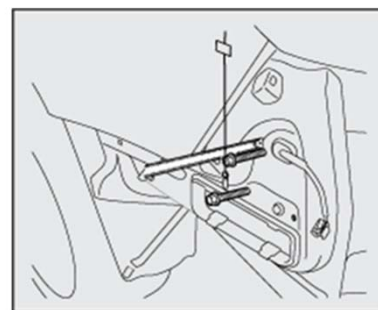
LH BSI Unit Mounting Area Check

- The system uses a radar unit located on each side of the vehicle behind the rear bumper.
- The system may malfunction and set DTCs because of damage, improper repairs, or excessive foreign material on any of the following:
 - Rear bumper
 - Outer side panels
 - Radar unit mounting locations
- Several checks and inspections must be done during repairs to the radar unit mounting area. If the mounting area check is not done, an Acura dealer may not be able to properly aim the radar units.
- For more information, refer to “BSI Radar Unit Mounting Area Check” in the service manual.

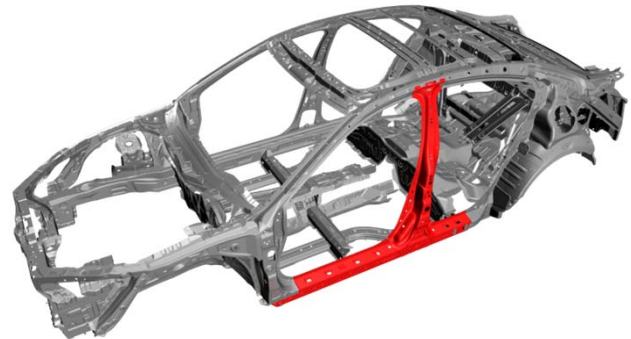
- NEVER attempt to straighten damaged 1,500 MPa steel parts because they may crack.
- 1,500 MPa steel parts MUST be replaced at factory seams using squeeze-type resistance spot welding (STRSW).
- MIG brazed joints should be used ONLY in locations not accessible by a spot welder.
- To assure adequate weld tensile strength, always set the spot welder to the specifications provided in the body repair manual.

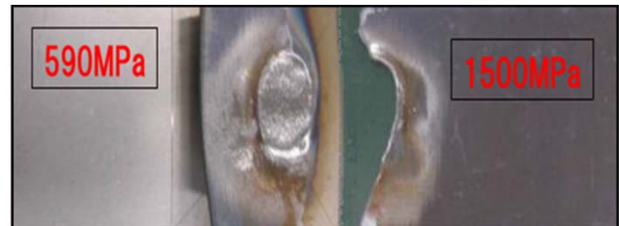
Tensile Test Results of Welded 1,500 MPa Steel

- NEVER perform MAG welding on 1,500 MPa steel. The heat generated during welding will significantly reduce the strength and structural integrity of 1,500 MPa steel parts.
- This photo shows tensile strength test results of welded 1,500 MPa steel. The 1,500 MPa steel fractured first, because the welding heat reduced its strength to far below 590 MPa.
- For more information, refer to “Hot Stamp (1,500 MPa) Parts Welding Specifications” in the body repair manual.

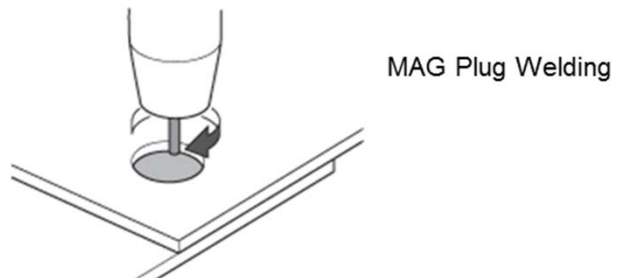
- MAG plug welding may be done when joining body components to 590-980 MPa steel parts.
- Follow the recommendations described in the body repair manual section “MAG welding specifications for high-strength steel parts 590 MPa and higher.”

MAG Plug Welds

Welding Wire Tensile Strength Must Be:
≥590 MPa (≥86 ksi)

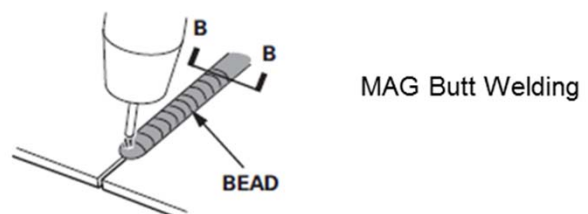
- MAG butt welding may be done only on steel parts with a tensile strength of 590 MPa and lower.
- Welding speed is critical to achieve the correct weld strength and minimize the heat affected zone (HAZ).
- Follow the recommendations described in the body repair manual section “MAG welding specifications for high-strength steel parts 590 MPa and higher.”

MAG Butt Welds

Welding Wire Tensile Strength Must Be:
≥590 MPa (≥86 ksi)

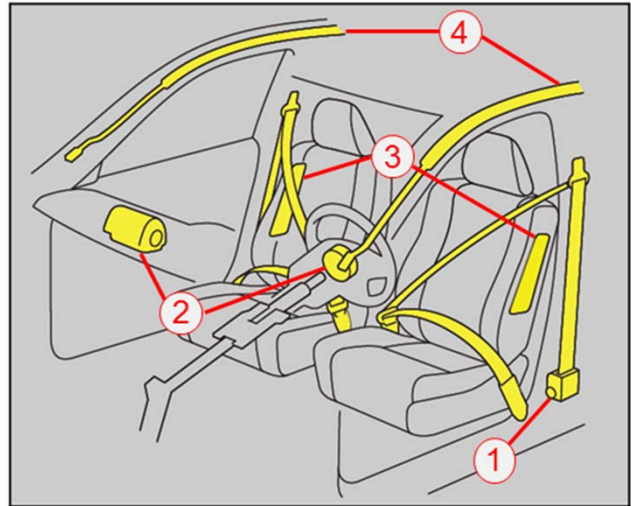
1. Driver and front passenger seat belt tensioners (may deploy independently from any airbags).
2. Driver and front passenger SRS airbags.
3. Side airbags mounted in the outer driver and front passenger seat-backs.
4. Left and right side curtain airbags mounted above the side windows under the headliner.

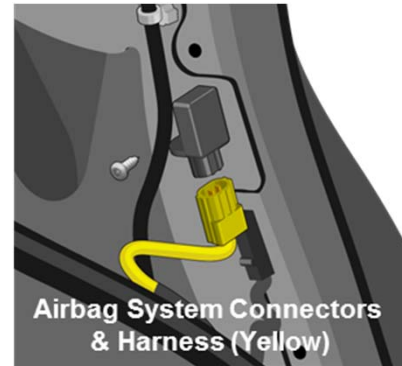
- For easier identification, electrical connectors that contain only airbag system wiring are yellow in color.
- Many harnesses that contain primarily airbag wiring are also wrapped in yellow tape.
- Airbag system wiring that runs in a common harness, such as a floor harness, is generally not marked.
- NEVER attempt to modify, splice, or repair airbag system wiring.

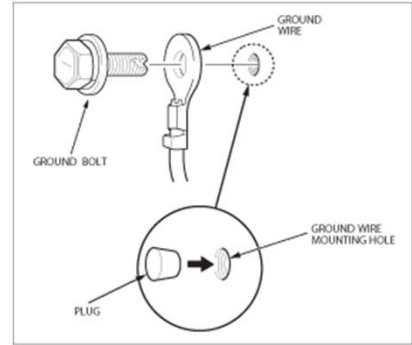
- Painting over electrical ground locations may cause electrical systems, such as Vehicle Stability Assist (VSA), to malfunction and set DTCs that may be difficult to diagnose.
- Protect the ground wire and the ground wire mounting hole threads with a bolt or plug when priming or painting.
